TECHNICAL NOTE

U.S. DEPARTMENT OF THE INTERIOR - BUREAU OF LAND MANAGEMENT

LUG BOLT TIGHTENING (1969 CHEVROLET TRUCKS)

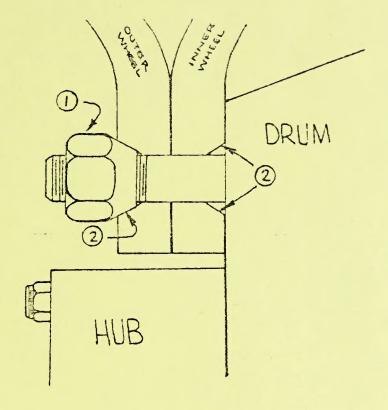
PRE-1969 STYLE

- 1 SELF CENTERING LUG NUTS
- TAPERED LUG BOLT HOLES

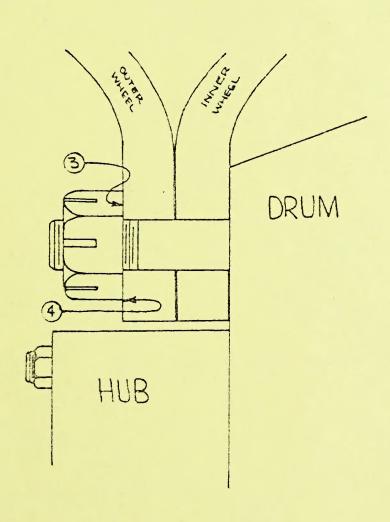
1969 STYLE

It has been reported that difficulty is being experienced in keeping the lug nuts tight on the 1969 Chevrolet Trucks, Model CE-30.

Upon checking with the Chevrolet Zone Service Manager, we learned that Chevrolet has received several reports on this problem. The Zone Representative indicated that the primary cause of damage was a result of failure on the part of the operator to insure that the lug nuts had been tightened to specifications and checked for tightness at the prescribed intervals listed in the Owner's and Driver's Manual. He acknow.ledged that Chevrolet is aware that the change in design of the wheel and lug nuts requires additional operator attention. To insure proper tightening, Chevrolet included additional instructions in the 1969 Owner's and Driver's Manual on the tightening procedure and frequency at which the lug nuts must be checked.

- 3 FLAT FACED LUG NUTS
- 4 FLUSH LUG BOLT RING FACE

On a new truck and after the wheel has been changed, the wheel nut torque must be checked at 100, 1,000, and 6,000 miles and every 6,000 miles thereafter.

Retorque wheel nuts to 75-110 ft. lbs. for 20-30 Series models.

Since this condition could have a far-reaching safety effect, we would like to recommend that all your drivers be made aware of the proper procedures for tightening and checking these lug nuts on the 1969 Chevrolet, Model CE-30 trucks. Your next safety meeting could provide an effective opportunity to instruct your drivers in the correct stepby-step method for installing and inspecting these truck wheels.
